OAKLAND POLICE ADMINISTRATION BUILDING

SEISMIC RETROFIT EVALUATION FOR THE "911" FUNCTION

Prepared For
The City Of Oakland
Office of Public Works

August 20, 1993

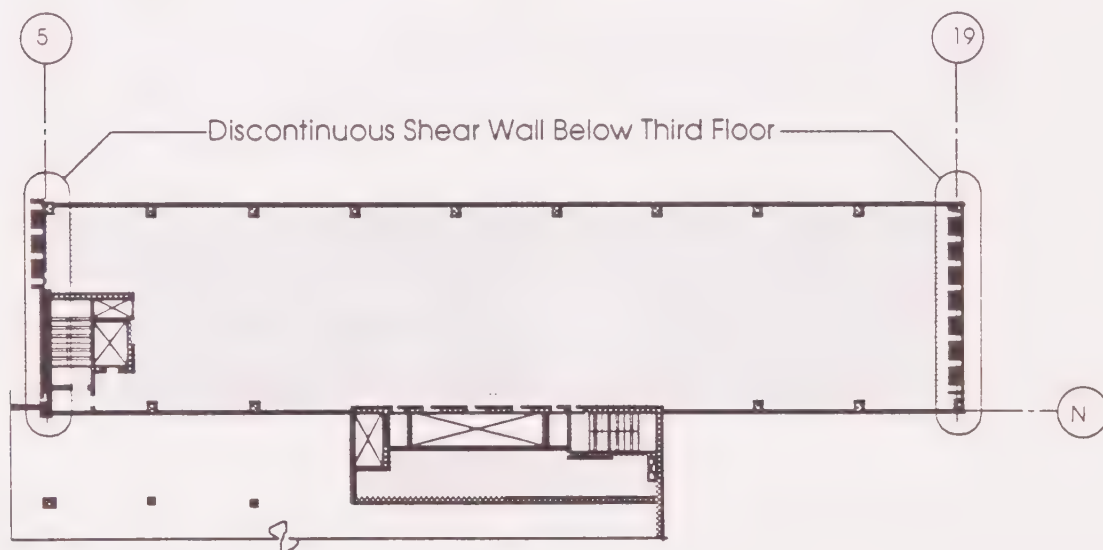
Figure 3: Discontinuous Shear Wall Below Third Floor

The Phase I evaluation identified the discontinuous shear walls on Lines 5 and 19 (see Figure 3) as critical structural weaknesses. Discontinuous shear walls are generally undesirable since they involve an abrupt change in the lateral load path. Often, such as in the Police Building, the absence of walls below results in a discontinuous lateral load path if the seismic forces in the wall cannot be transferred to adjacent structural elements. Columns supporting these walls lack ductile detailing features such as closely-spaced ties and 135-degree hooks, therefore, these columns will likely respond in a brittle manner under the high axial forces created by the overturning forces from the discontinuous shear wall above.

The columns below the discontinuous shear walls at the ends of the Tower building, e.g. at grid lines P/19 and N/19, were found to have excessive axial stresses due primarily to the overturning forces from the seven-story wall above. Column interaction diagrams were developed for the columns supporting the discontinuous walls, i.e. for columns at the intersections of gridlines P/5, P/19, N/19, M/9 and M/15. The interaction diagrams show the elastic capacities of the column for various combinations of axial and flexural loads, for a specified amount and arrangement of reinforcing steel. The estimated axial/flexural demand loads are plotted to determine their relationship to the column's capacity - points outside the curve indicate an overstressed condition in the column. Figure B-6 shows the interaction diagram for the column below the 2nd floor at P/19.

- 1) Add new concrete infill walls below the discontinuous shear walls on Lines 5, 9, 15 and 19 - see Figures C-5, C-6 and C-7. The new infill walls will require new continuous spread footing foundations.

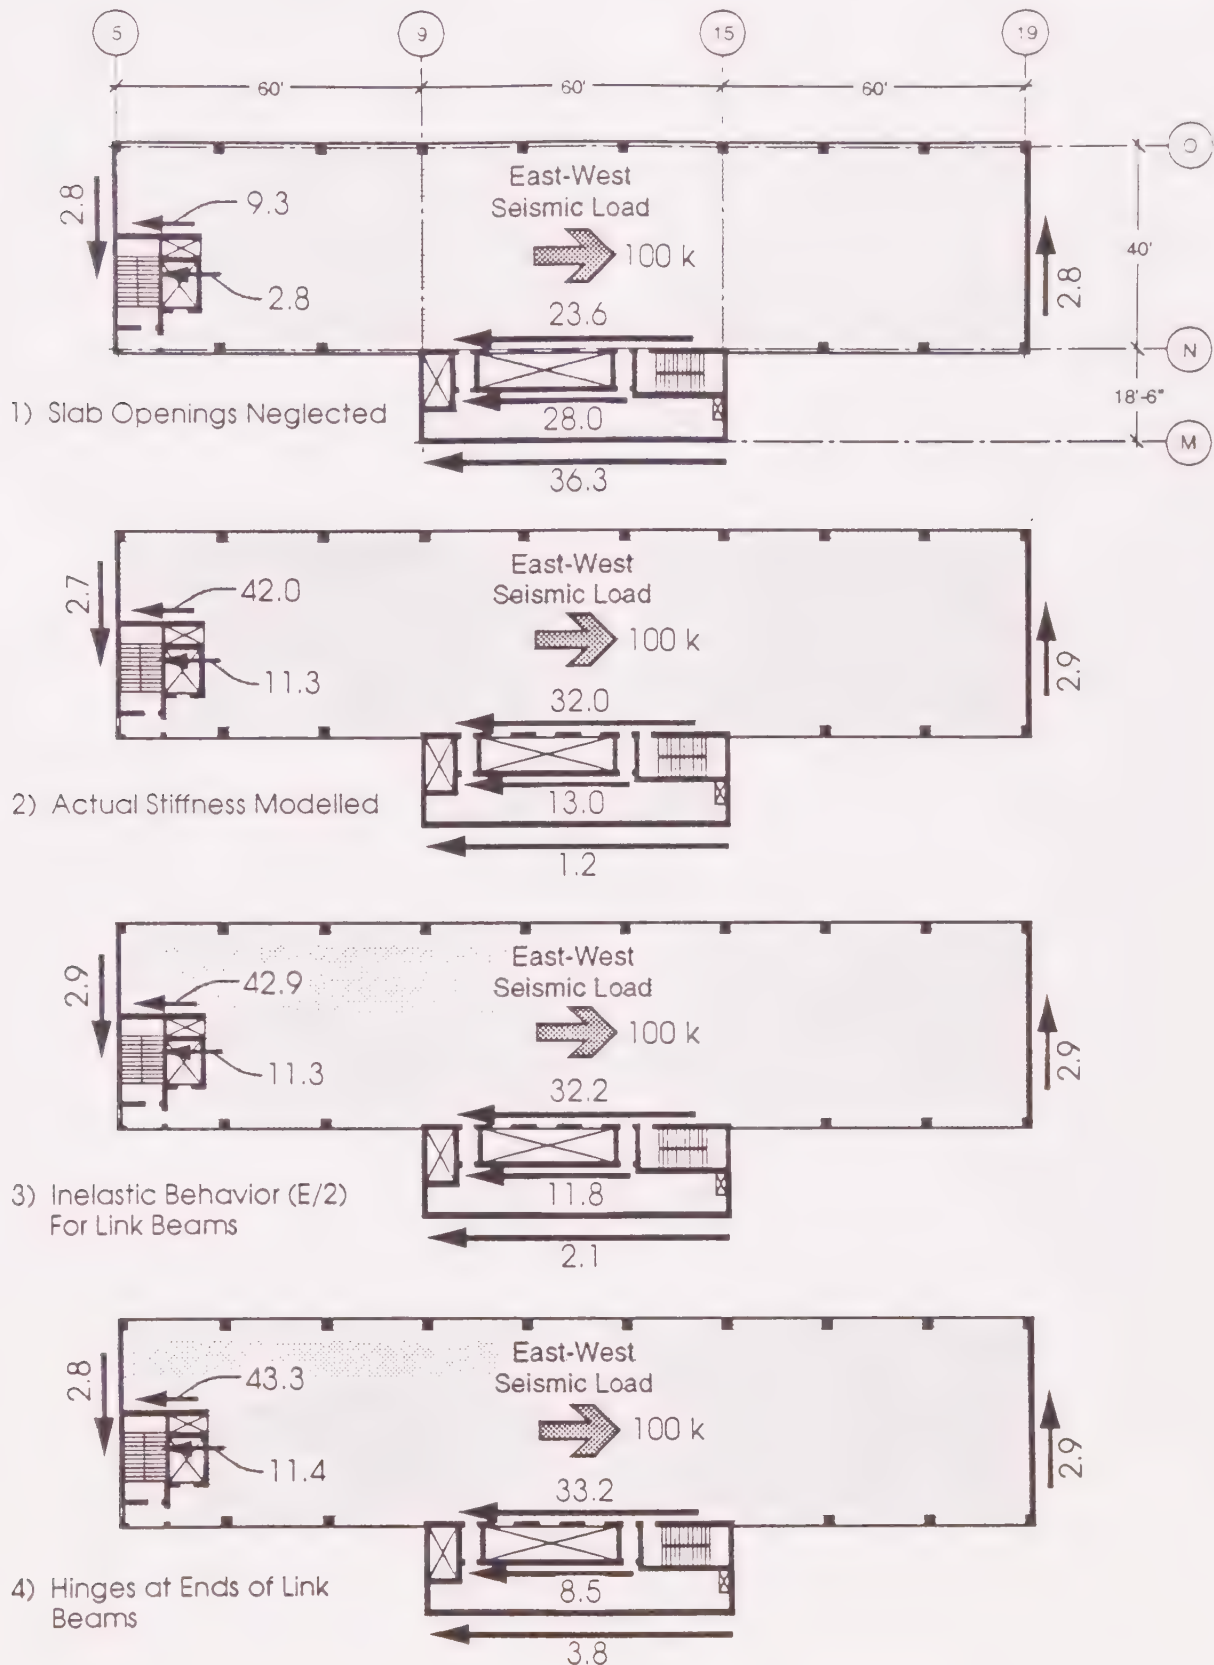
Figure B-2. Typical Tower Floor Slab Under East-West Seismic Loading

The 5' and 8'-9" wide slab sections between the north and south Tower areas were found to have excessive demand/capacity ratios for shear and flexure under east-west seismic loading.

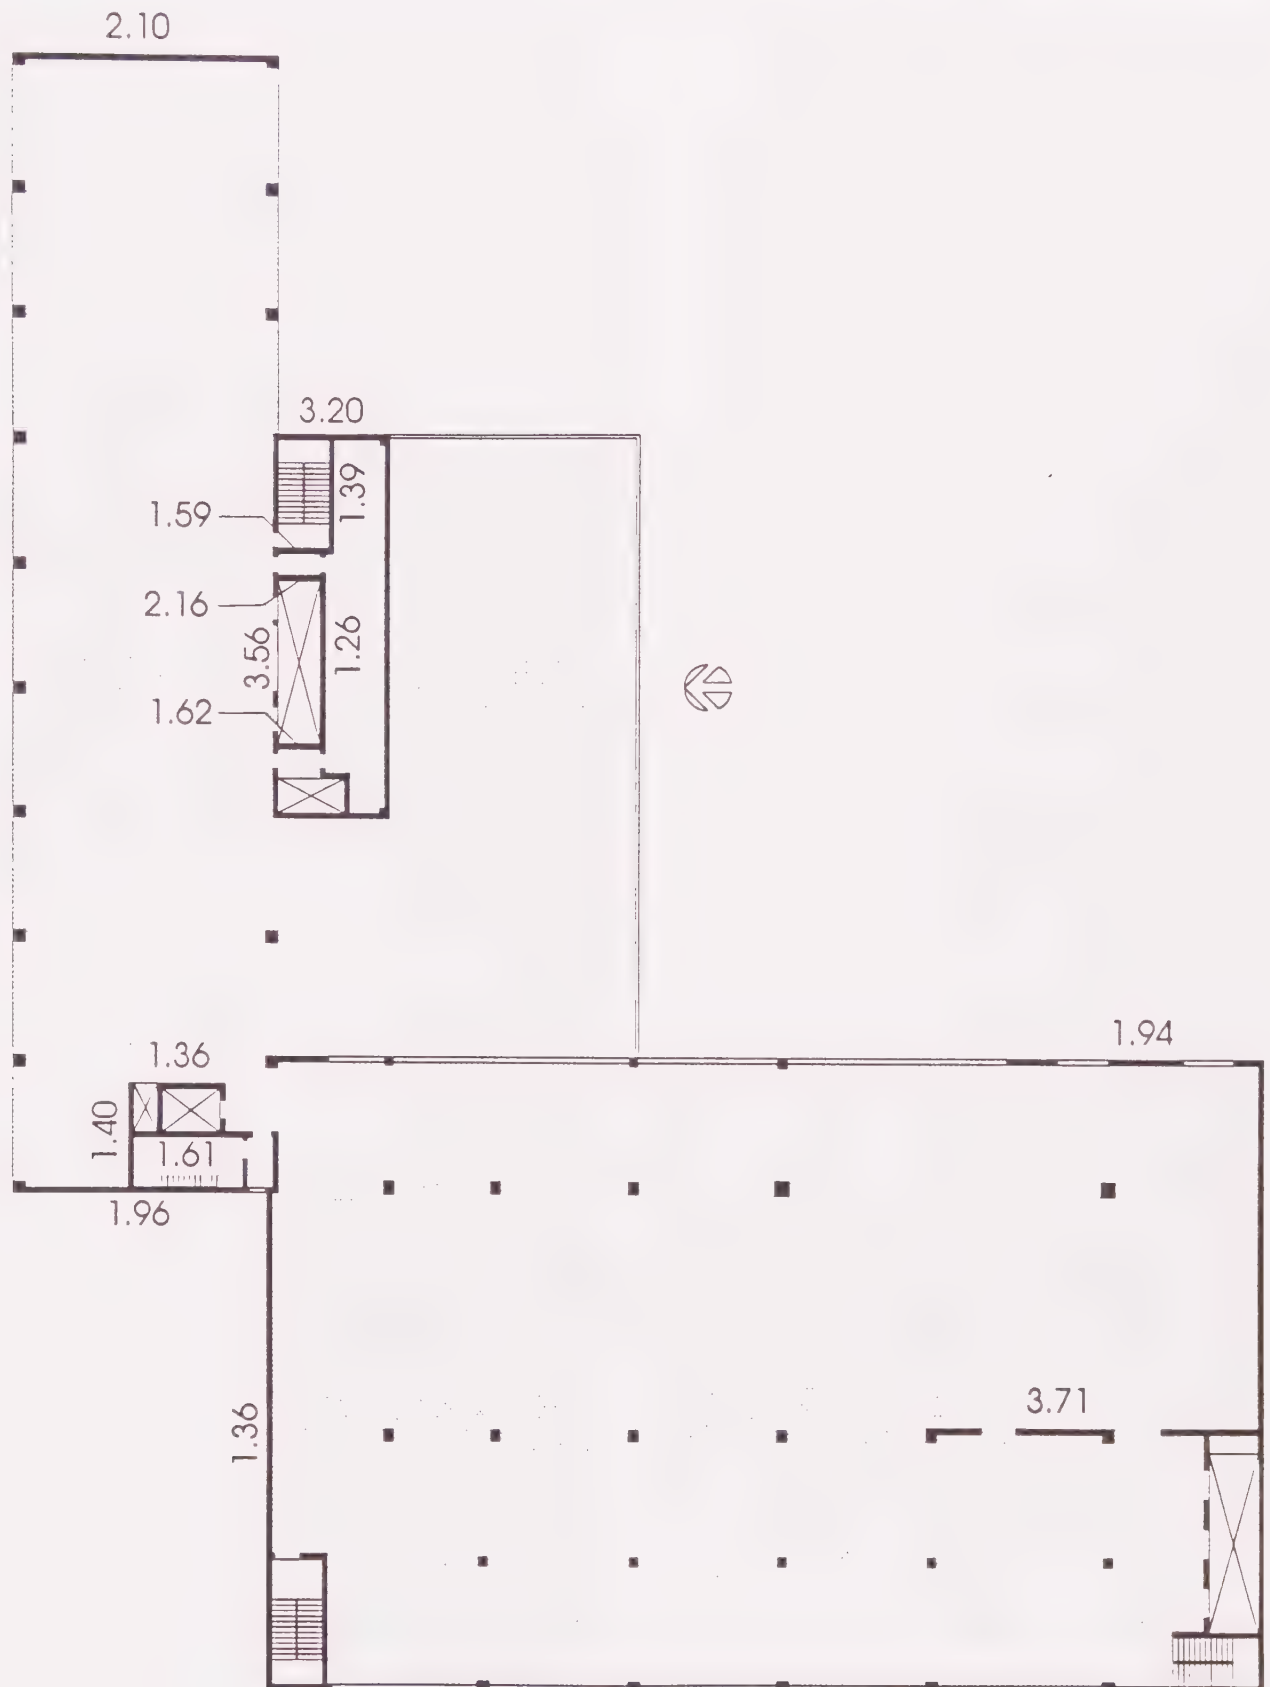
Figure B-5. Existing Building 4th Floor Plan with Inelastic Demand/Capacity Ratios

As described in the Performance Criteria in Section II of this report, DCR's up to about 1.25 are generally considered to represent an acceptable level of damage for shear in concrete walls for essential facilities. For the Courthouse area, designated as a nonessential facility, a higher amount of damage is acceptable, therefore, DCR's up to 1.5 were typically considered to represent acceptable states of stress.

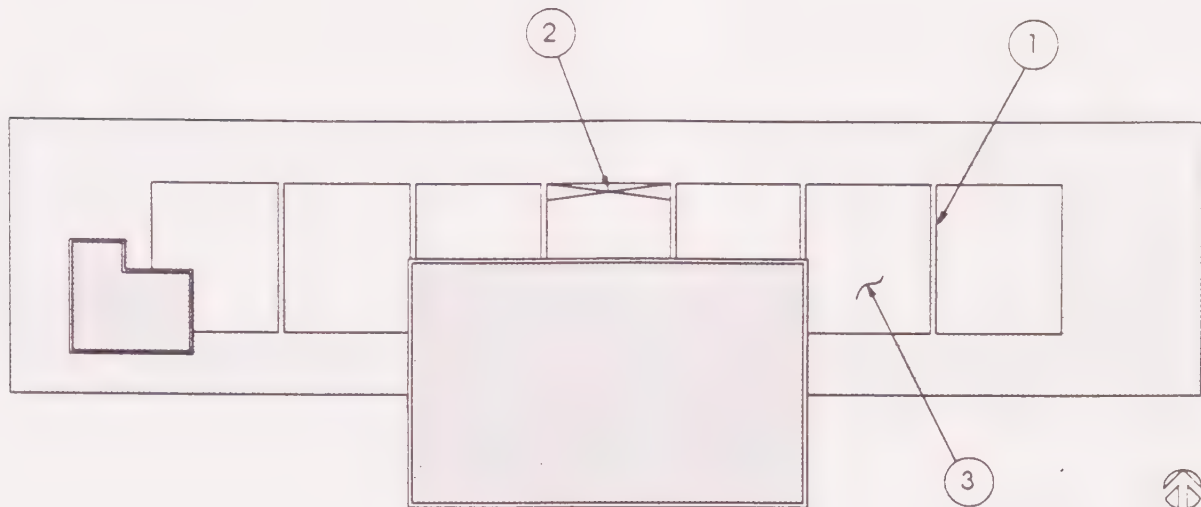
Figure C-1. Retrofit Scheme - High Roof Plan

The concrete rigid bents on the roof were evaluated for the high seismic roof accelerations and were found to lack adequate shear and flexural reinforcing in both the beam and column elements of the bents. Also, the bents lack adequate dowels attaching them to the roof structure. The concrete X-braced frame on the roof similarly lacks adequate tensile capacity in the diagonal members and is also only nominally attached to the Tower roof slab.

- ① Remove Concrete Slab and Rigid Bents
- ② Remove Concrete X-Brace
- ③ Remove and Replace Existing Equipment, Antennae, Etc. on Roof (not shown)

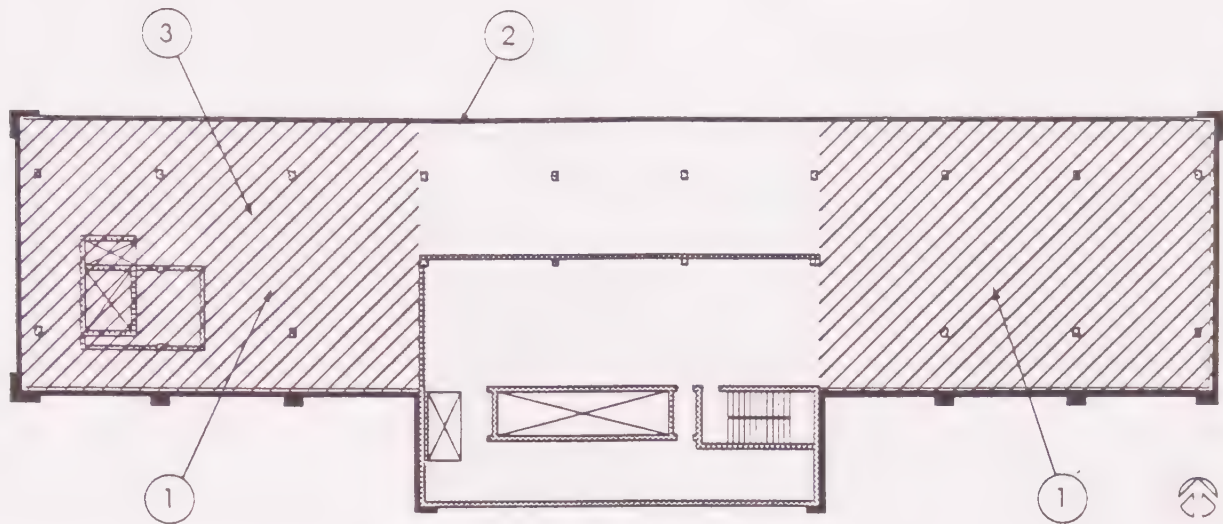
Figure C-2. Retrofit Scheme - Roof Plan

capacities of the slab and of the slab to wall transfer are were found to be excessive at the Tower roof but within acceptable ratios at the floors below. Also, the roof slab's chord and collector members were deemed inadequate for the postulated seismic forces. However, at the lower three floors, there is a lack of collector steel to transfer the seismic forces to the slab where the Tower walls are connected to the remainder of the building.

- ① Remove Existing Roofing and Topping Slab. Add New 4" Concrete Dowelled to Roof Slab.
- ② Form Curb for Waterproof Connection to Vertical Walls, Typ.
- ③ Traffic Top Waterproof Membrane at New and Existing Exterior Walkways, Typ.
